# TZ CONDENSATION CONTROL

## TZ-AC CONDENSATION CONTROL SYSTEM

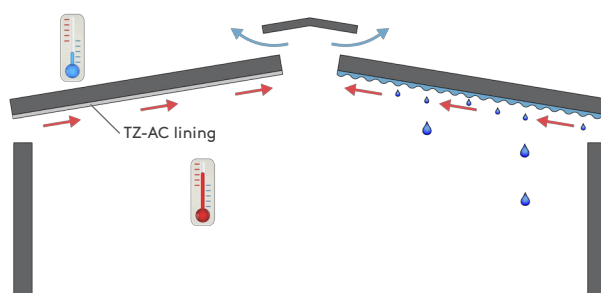
When the inside of an uninsulated or poorly insulated roof reaches the dew point, the water vapor inside the installation condenses in water droplets that can fall freely causing damage to property or equipment.

In certain environments, such as livestock facilities, condensation can be highly corrosive. Metal enclosures can be affected and significantly deteriorated in a short period of time.
